## PROJECTS

### HYDROGEOLOGY

#### Major WA Based iron Ore Miner

Assessment of the causes of hypersaline inflows into an under-harbour tunnel, Pilbara region, Western Australia.

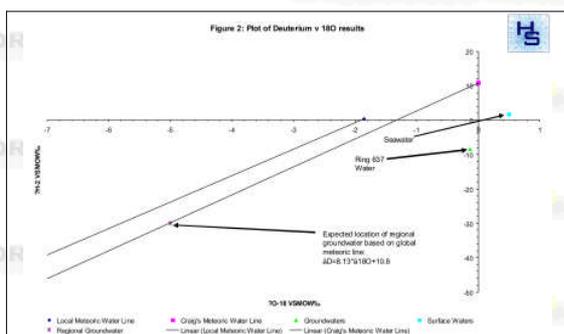
- The seepages were a mixture of between 50-76% seawater and 50-25% groundwater
- The seawater had a radiocarbon age of c7000 years, while groundwater was >>55,000 years old (i.e radiocarbon dead).

- The groundwater was likely to be 'connate' in origin, entrapped within sediments formed in an arid, tidally influenced depositional environment
- Hypersalinity may have been contributed to by membrane filtration through low-permeability aquitards above the basal sediments above granite bedrock
- Seepage into the tunnel was likely to have occurred due to the release of confined hypersaline groundwater possibly from the tunnel construction &/or investigation works
- A possible solution was proposed via depressurisation of the underlying confined aquifer units via pumping to promote normal seawater intrusion.
