PROJECTS

SITE REMEDIATION

HONG KONG ENVIRONMENTAL PROTECTION DEPARTMENT/ SCOTT WILSON KIRKPATRICK Investigation & Rehabilitation of Tseung Kwan O Landfill, New Territories

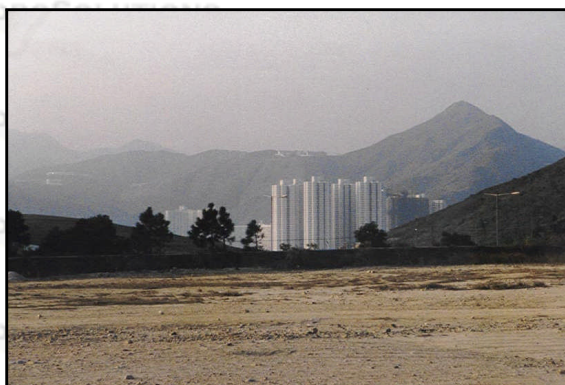
An investigation of the hydrogeology of the existing TKO landfill was undertaken on behalf of the EPD. The landfill was formed within a seawater embayment created by the deposition of rock and clay, which was then dewatered. Landfill then created a new raised platform approximately twenty metres above sea level, which was capped with clay & inert wastes.

Monitoring piezometers were constructed through the wastes and perimeter embankments to determine the saturated thickness of leachate and flow directions. Small-scale pumping tests were undertaken to determine waste permeability. The flow of leachate and effect of tidal variations were assessed for possible leachate recovery.

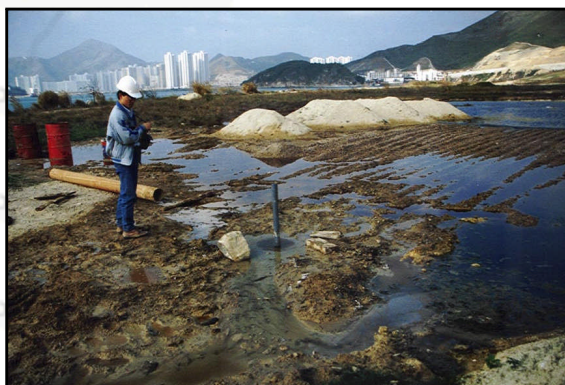
Samples of waste were analysed to determine their potential to generate landfill gases. An LFG pumping trial was conducted to determine the potential for extraction & utilisation. LFG extraction wells were constructed throughout the wastes.
